ENVIRONMENTAL REVIEW MEETING Grenada, Mississippi

Main Plant Site 16th Section Property Moose Lodge Road Disposal Area

> David O'Connor March 27, 2014

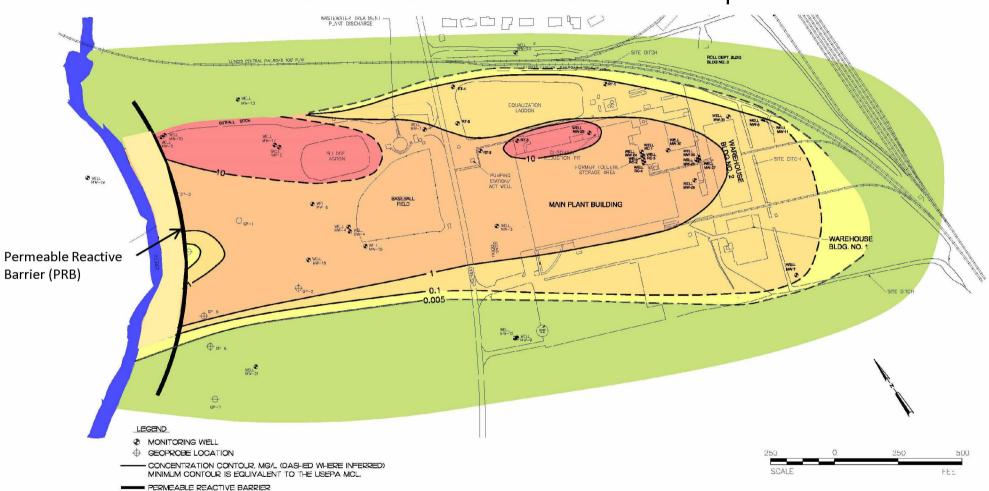
Groundwater TCE Concentration Map

Shallow Zone of Upper Aquifer

- The contaminant concentrations in the groundwater plume have declined significantly due to source control/treatment measures
- VOC impact to the creek declined significantly after PRB installation, and concentrations (VOCs and metals) in surface water remain consistently low

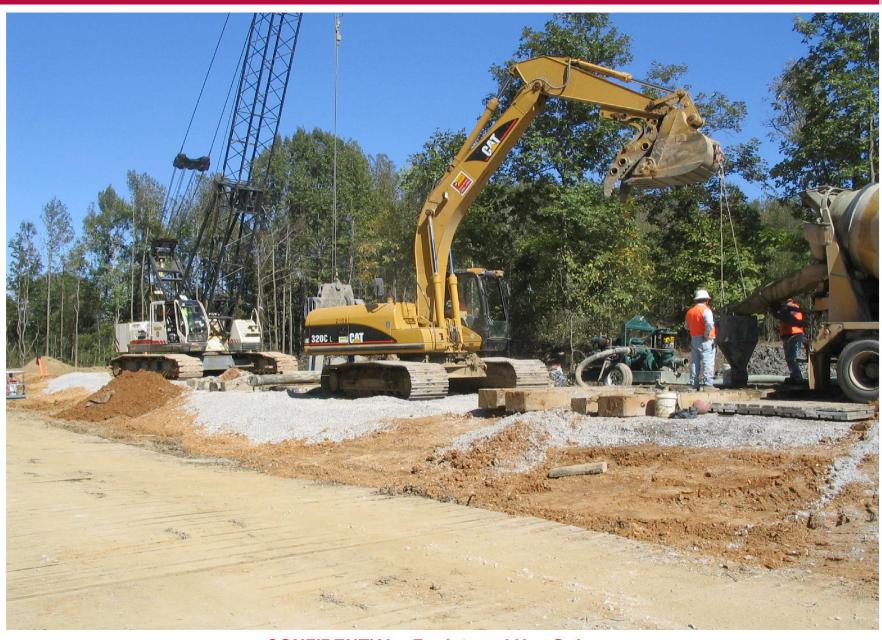
Appendix – Installing the PRB

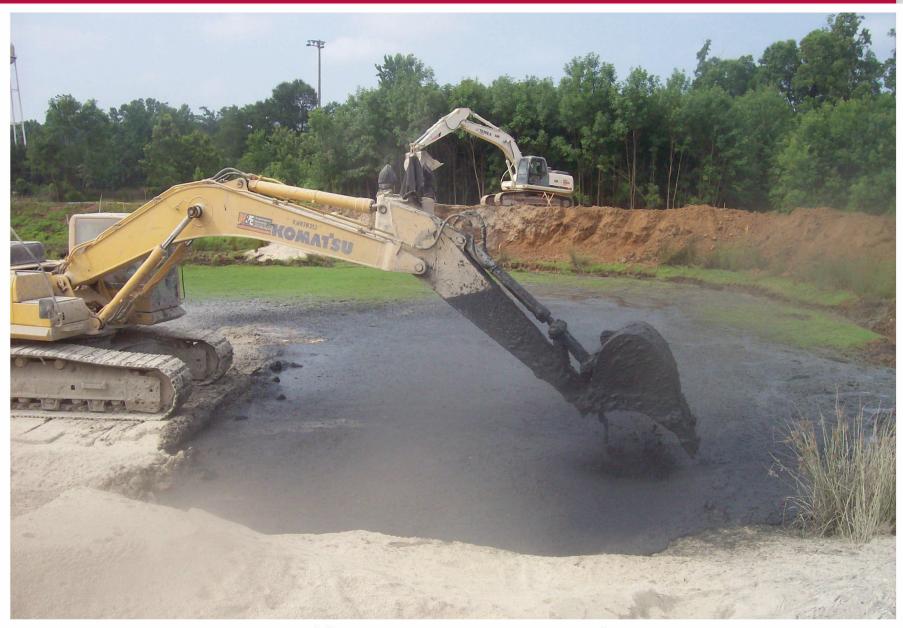
Appendix – Solidification of Sludge

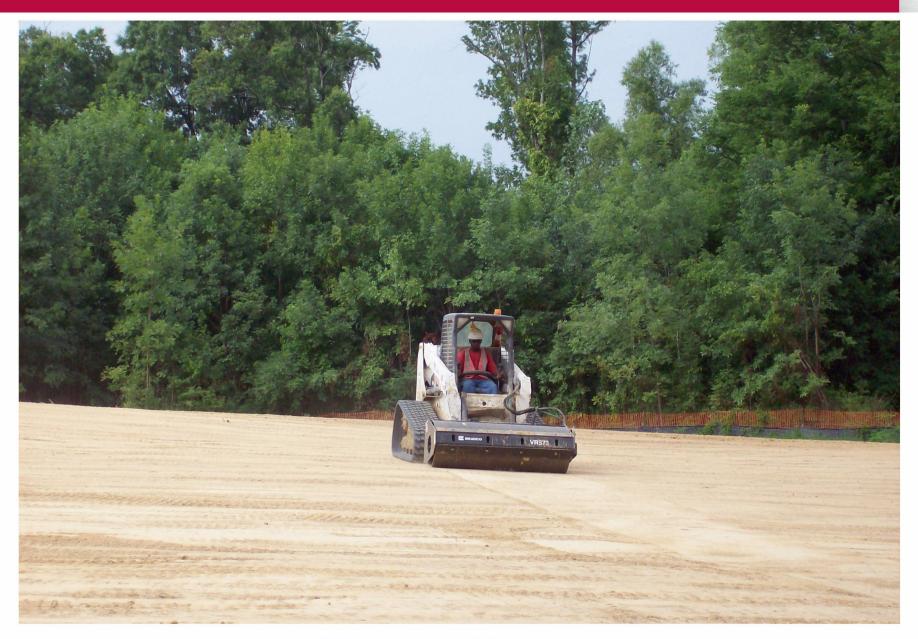
Appendix – Sludge Lagoon Soil Cap

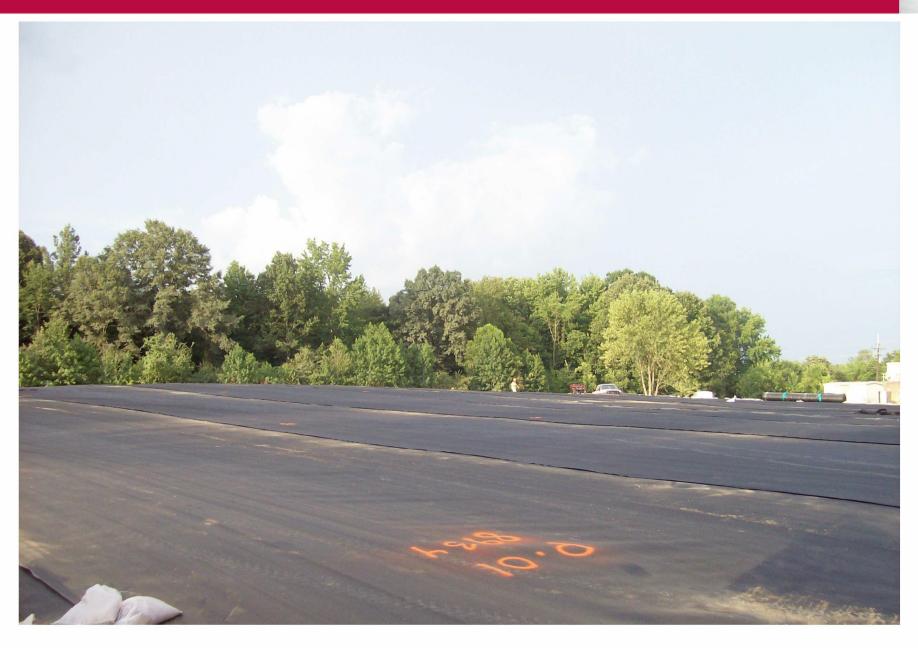
Appendix – Sludge Lagoon Liner Installation

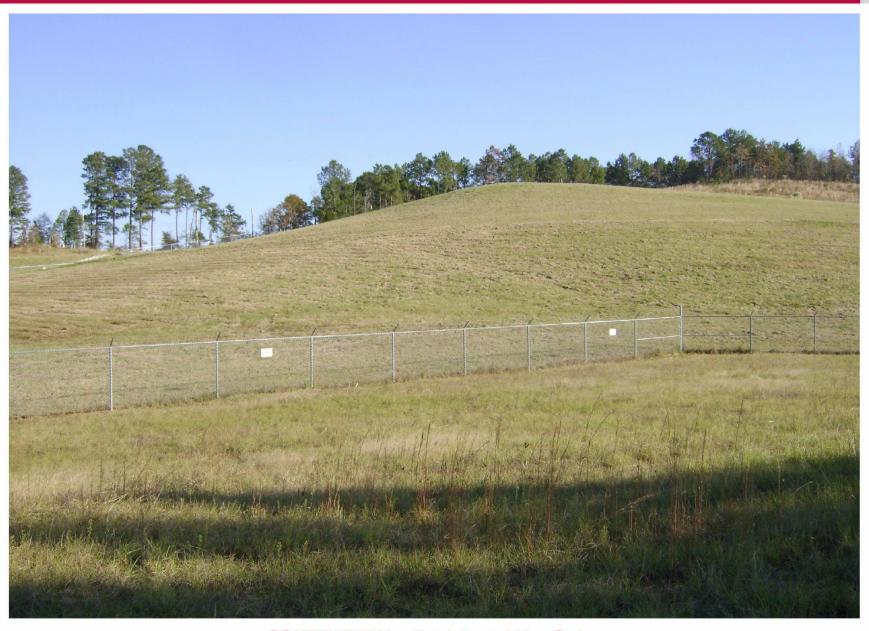
Appendix – 16th Section Landfill

- Regulatory oversight is through the Mississippi Department of Environmental Quality (MDEQ).
- Excavation of the waste materials for consolidation onsite under the landfill cap commenced in August 2004.

- The Construction Completion Report for the 16th Section Landfill Closure was submitted to MDEQ on December 6, 2005.
- Semi-annual groundwater monitoring has continued since closure of the landfill. The 25-year estimated present worth for required O&M, which includes groundwater monitoring and landfill cap maintenance, is \$638,000 (at 1.75% discount).

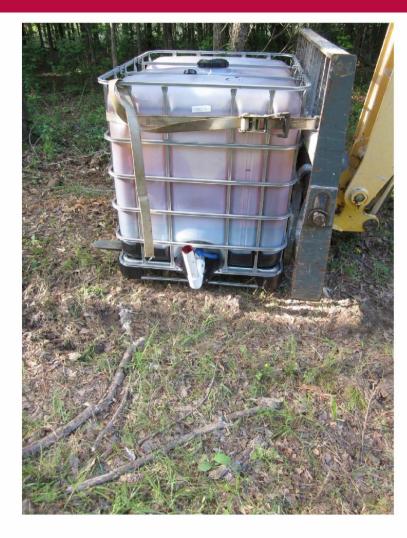
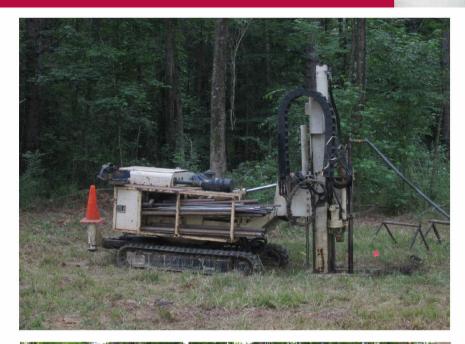
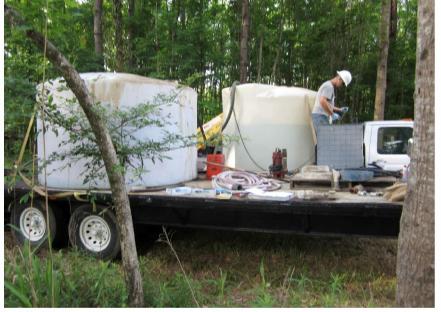
2012 ISCO Remediation Photographs (Clockwise from left): NaMnO₄ tote on forklift; Geoprobe delivering oxidant to subsurface; water tank and oxidant mix tank on flatbed trucks.

- Conducted Soil remediation 2007 2008 (i.e., buffing compound excavated and disposed at offsite landfill).
- Commenced In-situ Chemical Oxidation (ISCO) remediation in late 2009 with 3% potassium permanganate; completed treatment in early 2010.
- Groundwater monitoring results from 2011 and 2012 indicated oxidant was being consumed and chlorinated VOC concentrations were rebounding in some areas.
- Implemented second round of ISCO remediation in 2012 using stronger, more soluble oxidant sodium permanganate at 5 7 % concentrations.
- Continue remediation performance monitoring and reporting.
- Evaluate necessity of additional targeted ISCO treatments in areas where oxidant is readily consumed.
- Conduct risk assessment and evaluate need to continue active site remediation.
